# The Altar Machine in the Church Mother of Gangi (Palermo, Italy). Interpretation of the past uses, scientific investigation and preservation challenge

**Background:** The aim of this work was to study the Altar Machine in the Church Mother of Gangi, a little town near Palermo (Italy) regarding the history, the technical manufacture, the constitutive materials and the state of preservation.

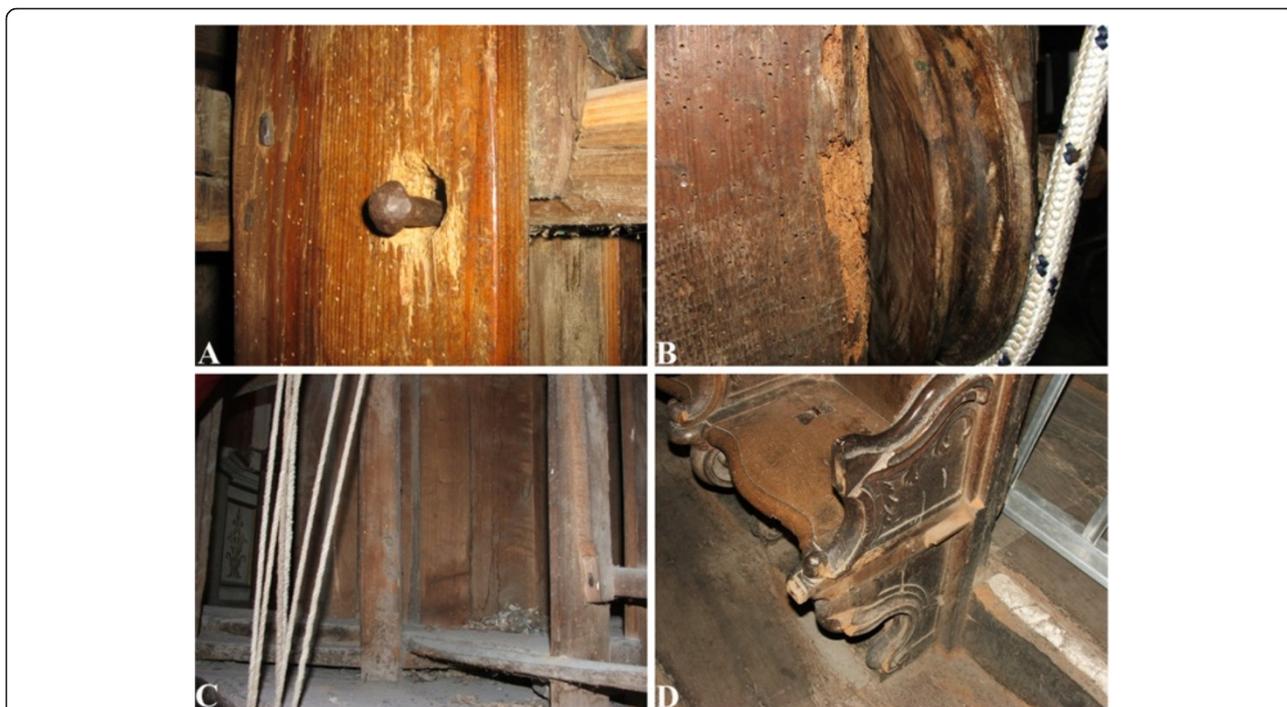
The carefully done in situ observation of the Altar Machine allowed detect several damages on the frontal polychrome surface, like cracks and detachments of the painted layers, whereas on the back side the wood elements are visible as they are not covered by any paint. So, the original wood defects were identified like knots, ring shake, etc. Moreover, wood deterioration was observed due to the wood manufacturing, to the Altar Machine usage, and to the microclimate of the church. Several scratches, dust, wood deformations, xylophages attack, and wood colour changes were observed (Figure 4).

**Figure 4** Some details of the damages in the Altar Machine. A) xylophages attack and scratches due to the use; B) xylophages attack and wood erosion; C) various kinds of stains and dirt layers; D) xylophages attack in the choir that encircles the Altar.

As referred in the background section, the carefully in situ observation of the Altar Machine allowed detect several damages on the wood elements like cracks, deformations, surface detachments and scratches, dust layers, colour modifications, and many holes caused by the insects. Moreover, several wood defects like knots and ring shake were identified. Wood deterioration was due to the manufacturing process, to the Altar Machine usage, and to the microclimate in the apsidal area of the church. The numerous galleries produced by the xylophagous insects weakened the wood, making the substitution of elements or the introduction of plugs necessary.

The several cracks observed in the Altar Machine generally follow the wood fibers and can be ascribed both to shrinkage/swelling caused by RH changes and to the movements of the Machine during its usage. A direct on-site monitoring of the mechanical damage in the wood elements could be performed by acoustic emission [32]. But in the case of the Altar Machine in Gangi it was not possible to perform this kind of analysis both for the high cost and also because the Machine is moved various times during the years.

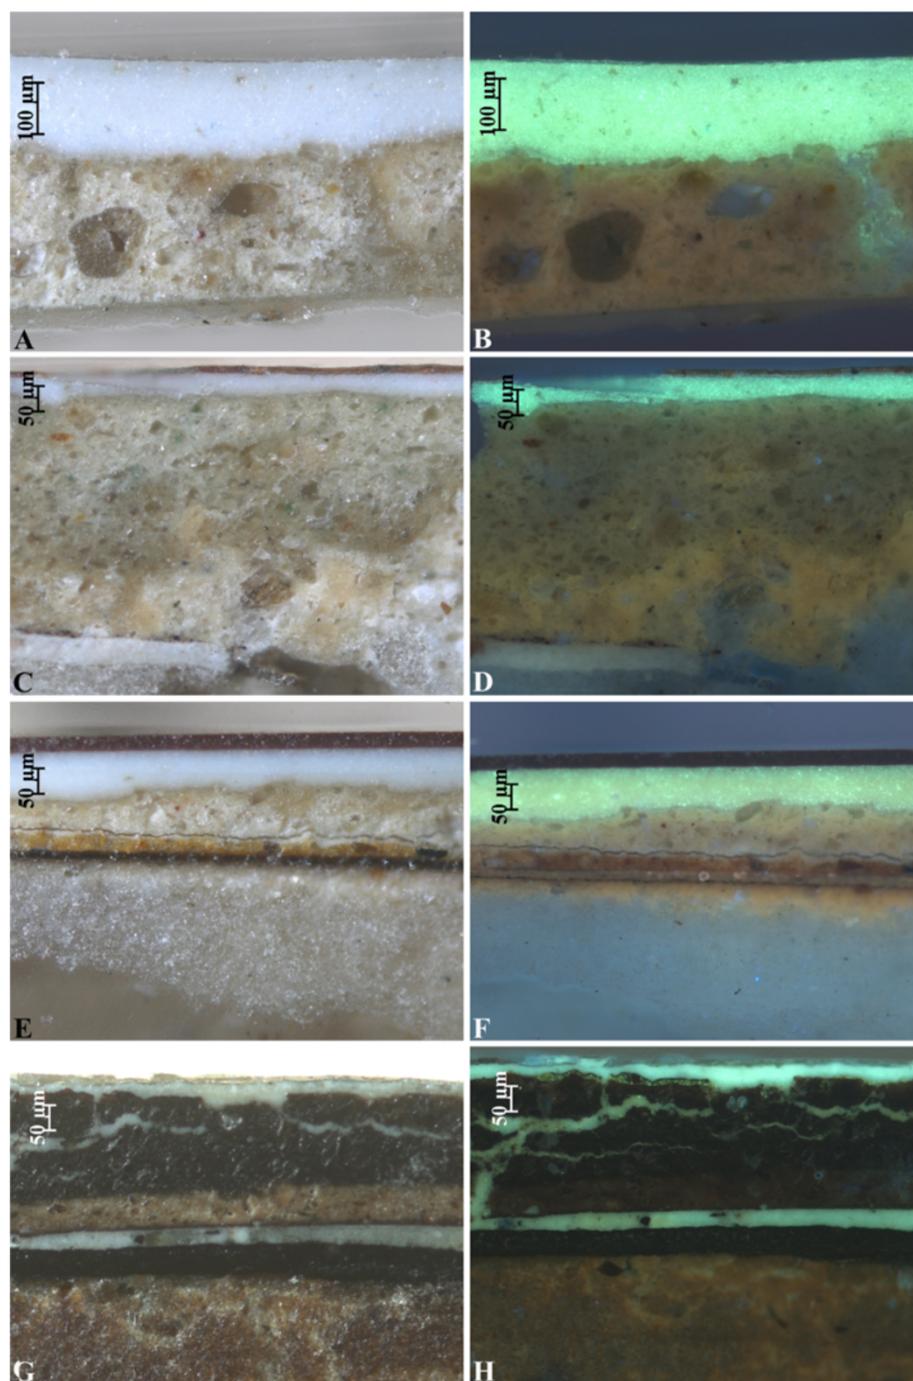
Stratigraphic and chemical analysis revealed the presence of superimposed layers constituted by several different materials. For this kind of artefacts it is usual to find many superimposed painted layers due to a continuous usage of the object that has got a demo-ethno anthropological significance. In Figure 5 the cross sections of the painting samples are showed. The white layer characterized by an intense yellow fluorescence is constituted by zinc white a pigment widely used starting from 19<sup>th</sup> century. According to this result it is possible to assess that the surface painted layer was certainly applied during the 19<sup>th</sup> or later. The painted layers were applied over gypsum and glue, as revealed by FTIR analysis and UV fluorescence examination of the cross sections. Glue exhibits a light blue fluorescence under UV lighting. At last, in sample ASN2 and ASN4 an orange UV fluorescence can be observed. This fluorescence can be associated to the presence of shellac, a natural resin often used with the function to isolate the priming or the support before applying the painted layers or the setting respectively.

XRF analysis revealed the presence of zinc in all the examined samples but also of lead (Table 2). According to this result we can say that the white layer, visible in sample ASN2 and ASN5 cross sections was probably made of lead white. This painting was realized previously in respect to that made of zinc white. The presence of iron suggests the use of red, yellow and brown ochre. The green grains visible in the cross section of sample ASN2 are made of a copper based pigment. Sample ASN3, defined as gilding, contains zinc and copper suggesting the presence of brass powder used to imitate gold. Arsenic is a component of the alloy. The use of brass to imitate gold was particularly diffused during the 18<sup>th</sup> century, especially to produce objects employed on the occasion of popular and traditional festivities [18].

**Figure 5** Microphotographs of samples ASN1 (A, B), ASN2 (C, D), ASN4 (E, F) and ASN5 (G, H), under reflected light (A, C, E, G) and UV fluorescence (B, D, F, H).

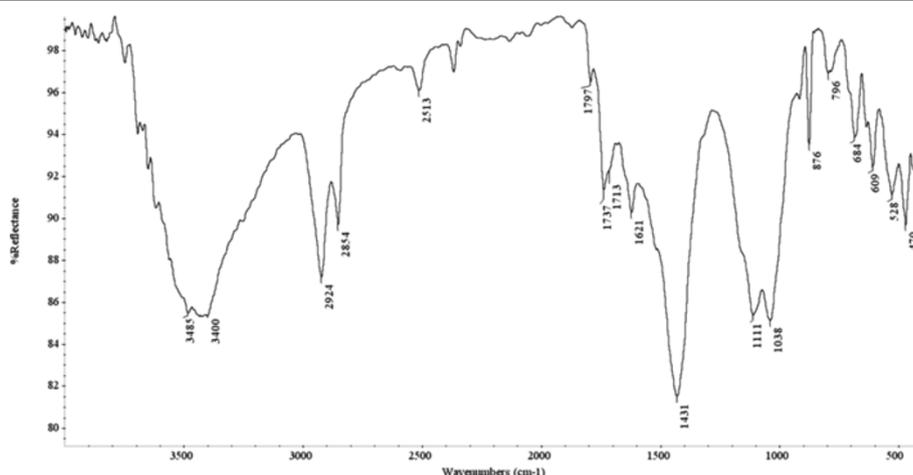
As example of infrared analysis result, the FTIR spectrum of sample ASN1 is showed (Figure 6). The main compound is gypsum with the bands at: 3485 cm<sup>-1</sup>, 3400 cm<sup>-1</sup>, 1621 cm<sup>-1</sup>, 1111 cm<sup>-1</sup>, 684 cm<sup>-1</sup> and 609 cm<sup>-1</sup>. Moreover, calcium carbonate (bands at: 2513 cm<sup>-1</sup>, 1797 cm<sup>-1</sup>, 1431 cm<sup>-1</sup> and 875 cm<sup>-1</sup>), a siccative oil

(bands at 2924 cm<sup>-1</sup>, 2854 cm<sup>-1</sup>, 1737 cm<sup>-1</sup> and 1713 cm<sup>-1</sup>) and iron oxides (peak at 528 and 470 cm<sup>-1</sup>) are present. In sample ASN4, also the bands associated to proteinaceous compounds have been detected, in particular the 1540 cm<sup>-1</sup> peak due to amide II [16,17].

**Figure 6** FTIR spectrum of sample ASN1.

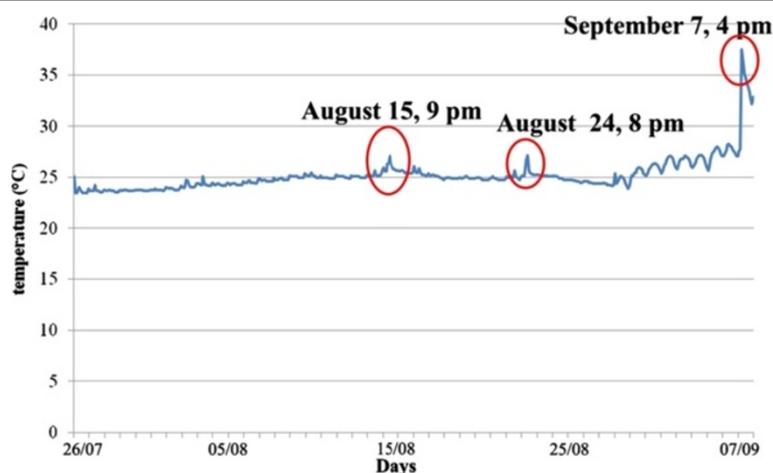
By analysing the microclimatic data, two little peaks of temperature were registered in August (15<sup>th</sup> and 24<sup>th</sup>) in the afternoon. They are due to the presence of many believers in the church (Figure 7). During August 15<sup>th</sup>, in fact, the Altar Machine is usually moved on the occasion of the *Assumption Day*. On August 24<sup>th</sup> there was a

**Figure 7** Graph of the temperature against time over the entire monitoring period.

During the first days of September temperature values raised considerably and RH values decreased.

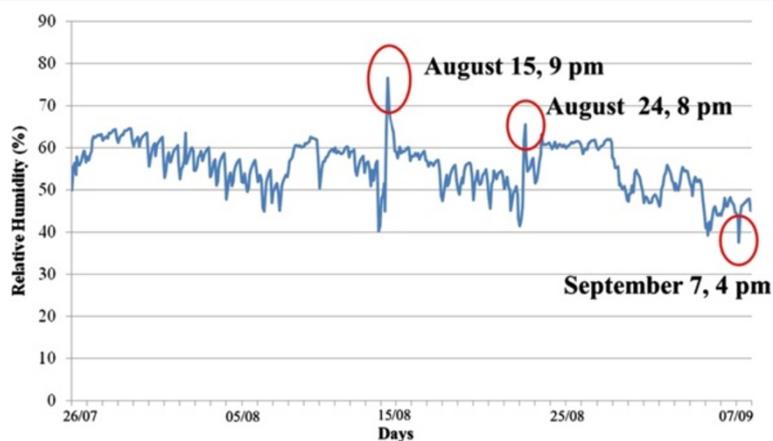
celebration to ordain a priest and so again many believers crowded the church. In correspondence of the two peaks of temperatures, high values of relative humidity have been registered (Figure 8).

In the heritage conservation perspective, the change in indoor climate needs to be interpreted in terms of impact on specific objects. The RH variations, controlled by temperature and moisture, are key factors in the conservation of the painted panels of the Altar Machine.

**Figure 8** Graph of the relative humidity against time over the entire monitoring period.

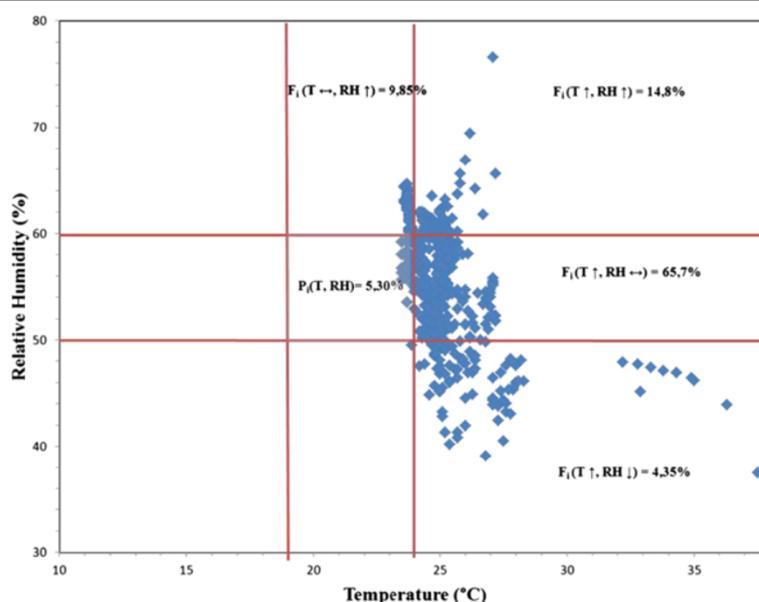
The tolerance matrix (Figure 9) is particularly useful for the microclimate studies [14].  $P_i$  represents the Performance Index that is the set of T and RH data falling within the tolerance range.  $F_i$  is the failure index that is the percentage of T and RH values falling outside the tolerance range. In general it is possible to assess that most data fall outside the tolerance area and only 5,30% is within the range. It is interesting to note that most data (71,0%) fall within the area where RH values are acceptable whereas T values are too high. But, T values appeared quite constant; on the contrary RH values fell almost always inside the s. i., but they often exhibited dangerous variations.

**Figure 9 T and RH performance and failure index in the tolerance matrix.** The grey area defines the tolerance area for painted wood, painted wood sculptures, painted panels, according to UNI10829.
