# The Altar Machine in the Church Mother of Gangi (Palermo, Italy). Interpretation of the past uses, scientific investigation and preservation challenge

**Background:** The aim of this work was to study the Altar Machine in the Church Mother of Gangi, a little town near Palermo (Italy) regarding the history, the technical manufacture, the constitutive materials and the state of preservation.

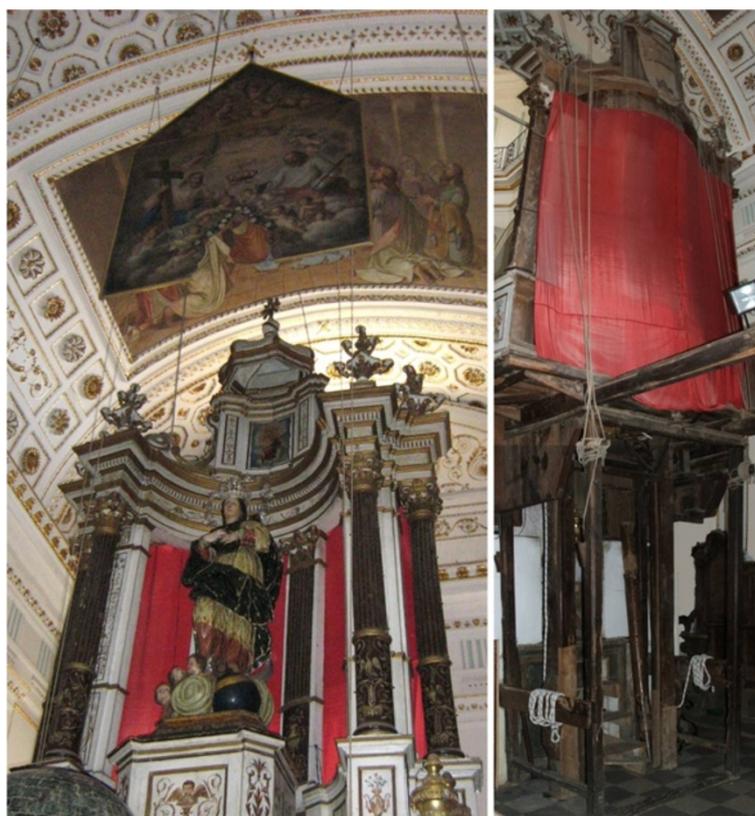
The upper and frontal part of the altar is carved and painted whereas the back side shows the bare wood (Figure 2). The lower part of the machine, hidden by the marble altar and by the *predella*, has a bearing function and contains a winch connected to some pulleys by means of ropes. This winch has the function to move the Altar Machine allowing put on the Virgin's Apotheosis in the evenings of 14 and 15 of August. This event is named by the local people with the dialect expression: "*acchianata da Madonna*" (the Virgin's Ascent) [3]. In particular, during the August celebrations, the machine movement causes the ascent of the Virgin's statue and simultaneously the descent of a painting that portrays the Holy Trinity while crowning the Virgin (Figure 2). When the statue and the painting meet – the silver crown of the statue fills the cavity visible on the painting – the painting is suddenly raised and it disappears behind a red velvet curtain.

**Figure 2** A general view of the Altar Machine, front and back. The Holy Trinity painting is also visible.

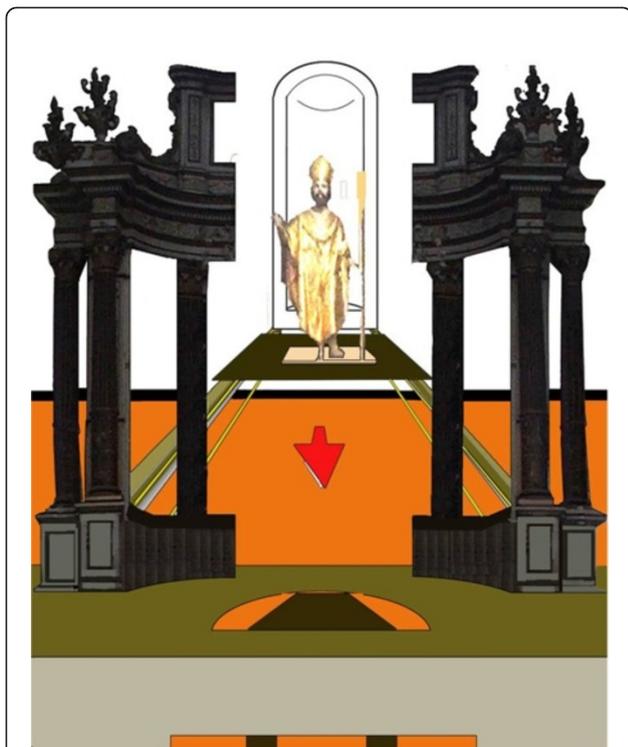
bolts in the upper and lower part of the Machine allowed us hypothesize that probably the Machine opened enabling the *San Nicola* statue to move forward (Figure 3).

**Figure 3** A virtual reconstruction of the Machine with the supposed opening and the San Nicola statue that moves forward.
